Heavy Loaded Parts of Petrochemical Equipment Destruction Cause Investigation

A B LAPTEV¹, S A NAPRIENKO¹, R ZH AKHIYAROV², A V GOLUBEV³

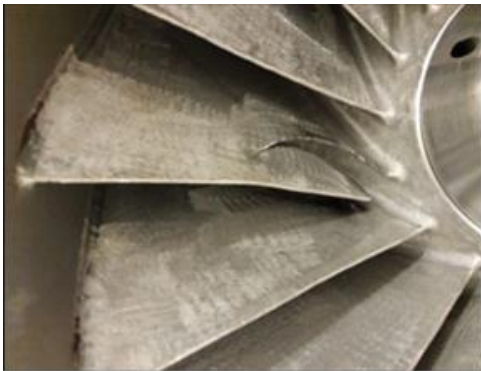
Insufficient control of the finished after casting air fan part after destruction was investigated in the work to assess the cause of the destruction of the impeller blade, which is one of the components of the inlet guide vane for controlling the compressor power of the refrigeration system [13]. During the operation the impeller blade was destroyed (Fig. 1).

Fig. 1: External view of impeller blade destruction.

The impeller operates at a temperature not higher than 35 ° C and a rotation speed of up to 9500 rpm.

In the area where the blades are connected to the shaft attachment sleeve, each blade experiences tensile and bending loads. The impeller is made of silumin.

The destruction of the impeller blade during operation occurred due to the initiation and propagation of a crack under the influence of an external load. The cause of crack initiation is the large heterogeneity of the cast material. The crack originated near the pore (the void formed during the casting of the product and the accumulation of aluminum oxides and fluorides. This heterogeneity is due to the peculiarities of metallurgical production [15], [16].

To exclude voids and foreign inclusions, each casting must be subjected to non-destructive testing (X-ray, ultrasonic or current-vortex methods).

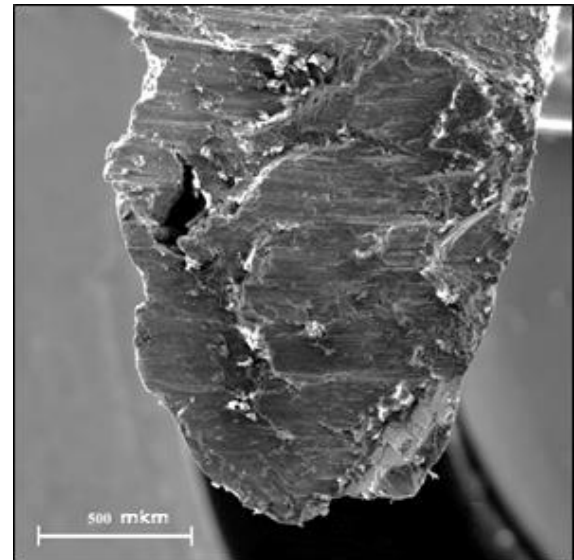
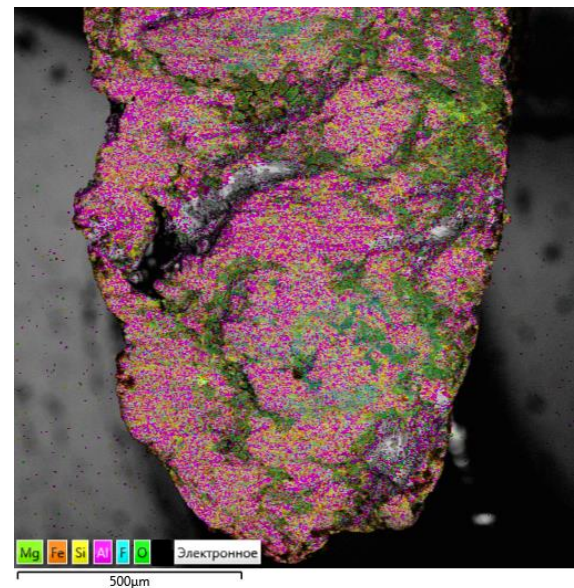
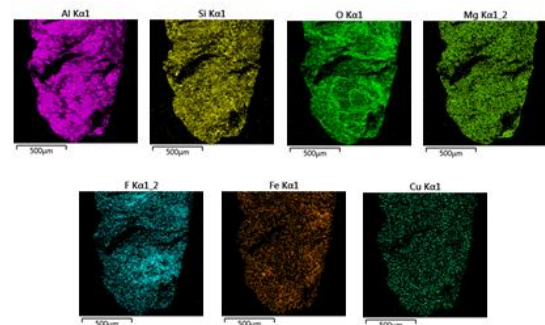
In Fig. 2 shows a photograph of impeller blade destruction surface in the secondary electron mode (the contrast is determined by the topography). It can be seen that the crack surface has a dark color and a

slate macro-relief, reflecting alloy structure. The morphology of service fracture surface from the source zone to the zone of static fracture formed during crack opening is the same and is represented by a brittle transcrystalline cleavage oriented along the crystallographic planes of the α -phase.

Fig. 2: Fracture surface of the impeller blade (A, Spectral mapping of the fracture surface of the impeller blade (B).

The focal zone is located on the edge of the blade and contains metallurgical defects in the form of a void (Fig. 2. Voids are a typical type of rejects in the place of pouring the melt by centrifugal casting. As for the inclusions, it can be concluded from the results of X-ray spectral microanalysis that these are aluminum oxides and residues of aluminum fluorides.

The presence of aluminum fluorides in the focal zone of destruction is due to the fact that in the production of aluminum alloys, a fluoride-chloride electrolyte is often used as an electrolyte in the electrolytic refining of aluminum [14].

As a result of the impeller blade airfoil surface roughness study, traces of machining were found near the crack. Studies have shown that the surface roughness of the material far from the crack is Ra - 40 μm. At the same time, the roughness near the crack is Ra - 129 μm, that is, 3 times more.

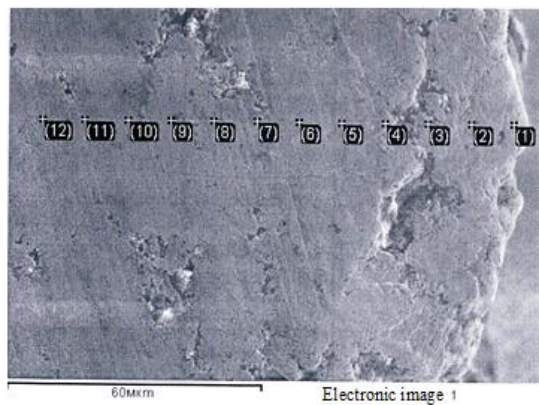
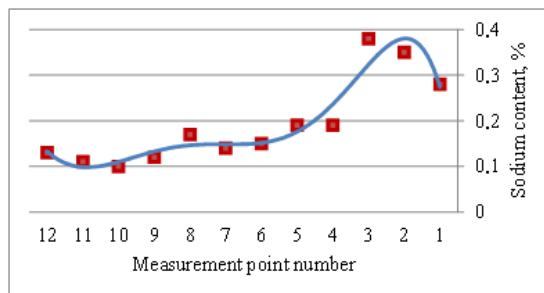
X-ray diffractometer determined the composition of deposits on the inner surface of a pipe sample, which is based on carbides, metal oxides penetrating to a depth of 100 microns (Fig. 3A), which indicates a significant destruction of the surface due to corrosion and the formation of coke deposits. A decrease in the amount of austenitic phase on the inner surface as compared to the outer one is shown. The pipe is heated on the outer surface, that is, it is most exposed to gas corrosion, but the development of local corrosion and cracks occurs on the inner surface of the pipe, that is, the environment inside the chimney affects the steel structure and intense corrosion.

Prepared thin section of the sample of the end surface of the research pipe with a step of 10 μm from the inner surface of the pipe to the outer one. The results of experiments to determine the sodium content in the near-surface zone of the metal are shown in the graph (Fig. 3B).

Fig. 3: Change in sodium concentration (A) along the profile (B) of the chimney section.

Fig. 3 clearly shows that the surface in contact with the vapor-hydrocarbon medium containing alkali (NaOH) has a high sodium concentration. Considering that the surface has been repeatedly washed with water, and sodium is well hydrated, there is little of it on the surface itself, and in the metal itself sodium is presented in the form of a bound and chemically stable compound. Thus, the heat-resistant steel collapsed due to the high sodium concentration in the heated environment. Reducing the amount of supplied alkali will significantly increase the overhaul period of the furnace operation.

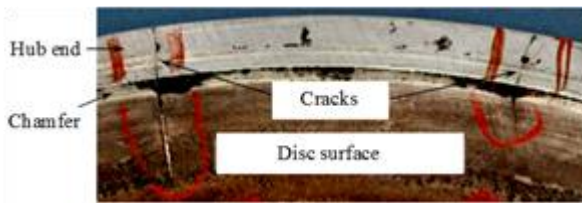
Fig. 4 shows the locations of fatigue cracks localization on the disk, which led to significant costs for replacing it, determining the causes of failure and, as a result, changing the manufacturing technology.

The outer diameter of the disc is coated with silver, which in some places is almost completely erased and in these places on the surface of the chamfer there are dark spots and cracks (Fig. 4).

The study of the fractographic features of the alloys was carried out on samples cut along the cracks (Fig. 4). It was found that corrosion destruction and the formation of both cracks began at the outer edge of the disk. The inner cavity of the crack is covered with oxides. The morphology of the fracture in the area where the corrosive environment was exposed is represented by the facet microrelief, which indicates the brittle nature of the fracture. A static dolly testifies to the viscous nature of destruction.

EDX found that the chemical composition on the surface of the disk sample, as well as on the surface of the cracks, contains silver, VT8 elements, as well as oxygen and chlorine.

Fig. 4: Cracked disc rims

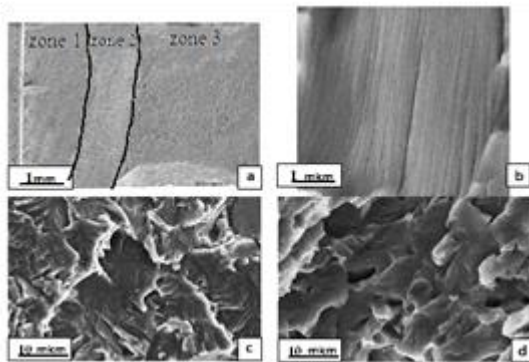
The fracture photograph shows the following zones (Fig. 5 a): fatigue crack propagation in air; crack development zone in the medium 3% sodium chloride solution; static downhole in the air. In this case, the first zone has characteristic fatigue grooves (Fig. 5 b). Failure in the second zone is represented by a brittle microrelief (Fig. 5c), similar to the operational one. The third zone has a structure similar to the first (Fig. 5 d).

Fig. 5: View of the fracture and fractography of the VT8 sample: a - three zones on the fracture surface of the VT8 sample; b - zone 1; c - zone 2; d - zone 3.

Tests of VT8 alloy specimens for resistance to the rate of crack growth in a corrosive environment showed the alloy's tendency to embrittlement and stress corrosion cracking in chloride-containing media, with the formation of a microrelief (Figs. 5 c, d), corresponding to a brittle one that is not typical for fracture in air, but identical to operational fracture (Fig. 4). Thus, the destruction occurred due to the embrittlement of the metal in the process of electrochemical corrosion in molten nickel chlorides, intensified by galvanic corrosion in the presence of a silver coating film.
