Failure Analysis of Distribution Transformer and Proposing Proper Solution to Mitigate the Faults -A Case Study of Kombolcha City Dessie District Ethiopian Electric Utility, Ethiopia

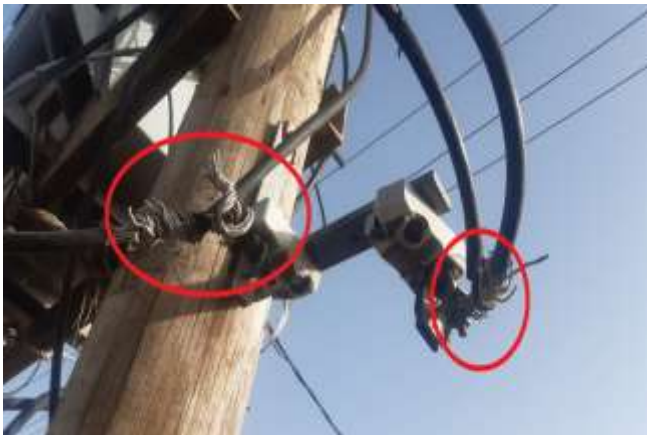
In many instances of our inspection, we had observed that using of higher rating of fuses or not using of fuses at all or use of unequal fuse rating size in one circuit were common circumstances with respect to fusing. The first reason was occurred, when transformer HRC fuses were blown off frequently, and the maintenance team replaces the fuse element of higher rating to avoid frequent interruption of supply and frequent replacement of fuses. The second reason occurred due to unavailability of proper size of fuse for replacement during maintenance activities. Figure 10 shows the picture of a typical DT operating without HRC fuse which we encountered during our field inspection of some distribution transformers.

Fig. 10: DT Operating without HRC Fuse

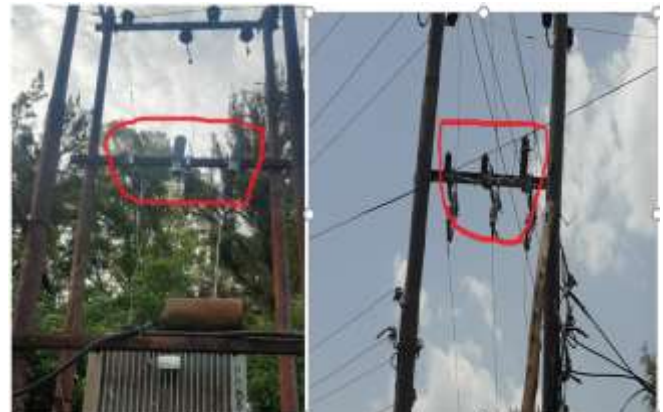
Fig. 11: Some of Unprotected DTs against Lightning

In Figure 11, the first transformer (left) is 100kVA with two outgoing LV feeder and located around Kombolcha general high school supplying power to the customers around the school and Biraro auditorium. For this transformer, the two lightning arrestors are not connected to the MV lines whereas the other one is missing. The second (right) transformer located around Kombolcha general hospital on the way to Woyraw with capacity of 315kVA. This second transformer has two outgoing LV side feeder providing power to the customers around the hospital. For this case too all the three lightning arrestors were not connected to the MV lines. In general, in both cases the transformers are not protected against lightning. This may cause the transformers to fail due to lightning stroke during summer season.

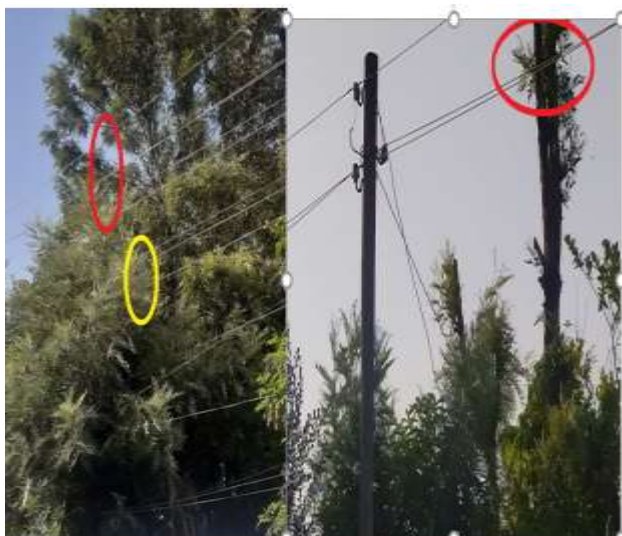
MV side short circuit fault does not cause fault to the transformer. But in case of an external short circuit on primary (LV) side affect the transformer to fail. Very large amount of fault current (approximately 20 to 25 times the rated current) will pass through the windings. The winding is designed to resist such a fault current not greater than 3 seconds. If the fault stays more than 3 seconds the transformer winding will be burned causing the transformer to fail. Figure 12, shows possible cause for external short circuit problem.

Fig. 12: MV and LV lines are in Contact with Tree Branches

By selecting the correct rating of protection device in the LV side or HRC fuse it possible to protect the transformer from damage from LV short circuit. But on – site investigation showed us, many cases were observed the distribution transformer with improper size of fuse, absence of fuse, and unacceptable fusing type on LV side are major reason for failure of DTs and affecting the safety of DTs.

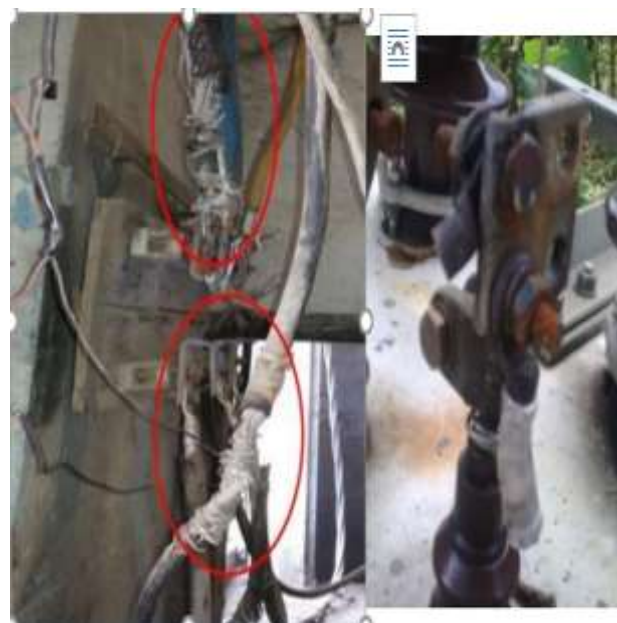
During our site inspection time, it had been observed, there were sparks from the bushing termination joints especially on L.V connections due to lose contacts. Sparks were happening because of loose terminations during the installation or else have been loosening due to poor service conditions. Once spark occurred at the cable termination, it causes melting of the busing sealing gaskets, effecting oil leakage from the bushing top, and later resulting in failure of the transformer in due course of time because of low oil level.

Also, during cable termination, we have to consider the effect of bimetallic action. If aluminum cable or conductors are to be connected with brass/copper terminal or vise-versa, a proper bi-metal remain in between. Due to bimetallic action, a milli-volt will generate causing a localized current and may deteriorate the current carrying thread, [11]. A typical picture of poor cable termination is shown in Figure 13.

Fig. 13: Damaged DTs part due to poor cable termination

Both the MV and LV terminals must be connected through suitable lugs and connectors. Direct Connection of cable/conductor to the bushing terminal must be avoided.
