Failure Analysis of Distribution Transformer and Proposing Proper Solution to Mitigate the Faults -A Case Study of Kombolcha City Dessie District Ethiopian Electric Utility, Ethiopia

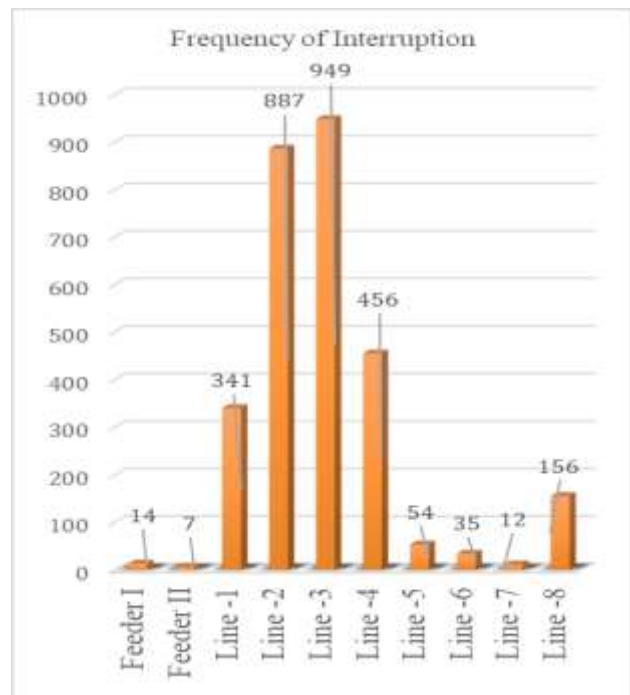
Fig. 2: Kombolcha Substation I Frequency of Interruption within 21 Months

The station recorded total frequency of interruption were 2,911 (21 from incoming side and remain 2,890 on load side) within 21 months. The data shows that, line two and three shares 30.5 and 32.6 percentages frequency of interruption accordingly as shown in Figure 2. These two feeders recorded 1836 interruption or 63.1% from the total interruption that happened on the station in the respective period.

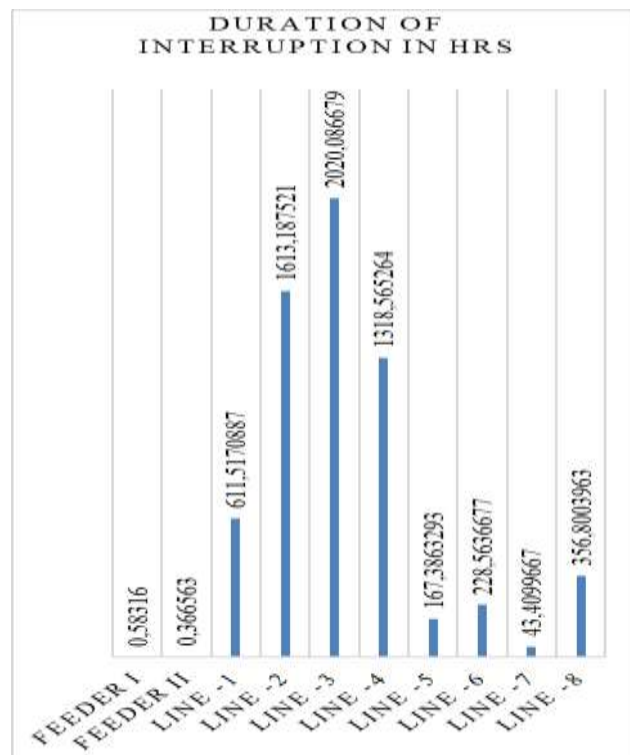
Fig. 3: Kombolcha substation I duration of interruption in hours within 21 months

As shown in Figure 3, the total duration of interruption was 6,360.5 hours within 21 months. Among this, line three had 2020.1 hours interruption duration, which means it sustained more than 406 hours than the other.

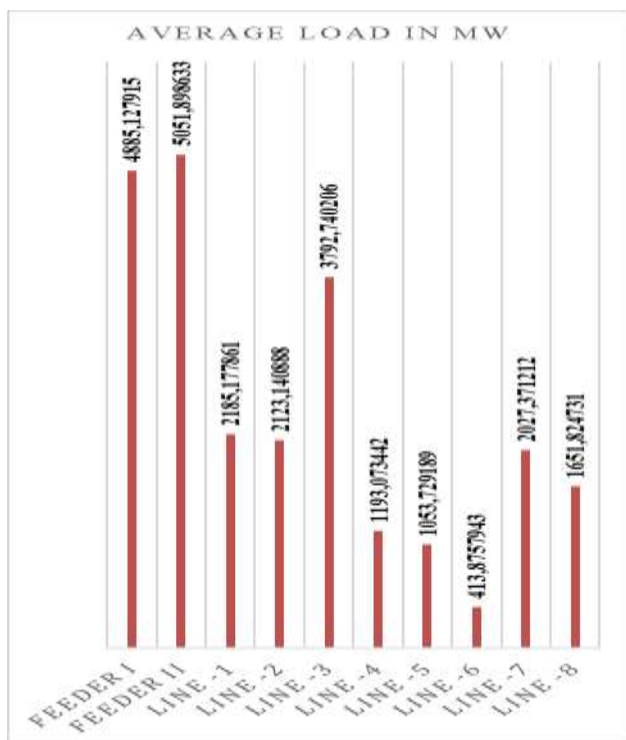
Fig. 4: Kombolcha substation I un-served average power in MW within 21 months

The sum of un-served power was 24,377.96 MW within 21 months because of uncontrolled interruption occurred on Kombolcha I substation. From this 3,792.7 MW power were un-served due to the interruption occurred in line three.

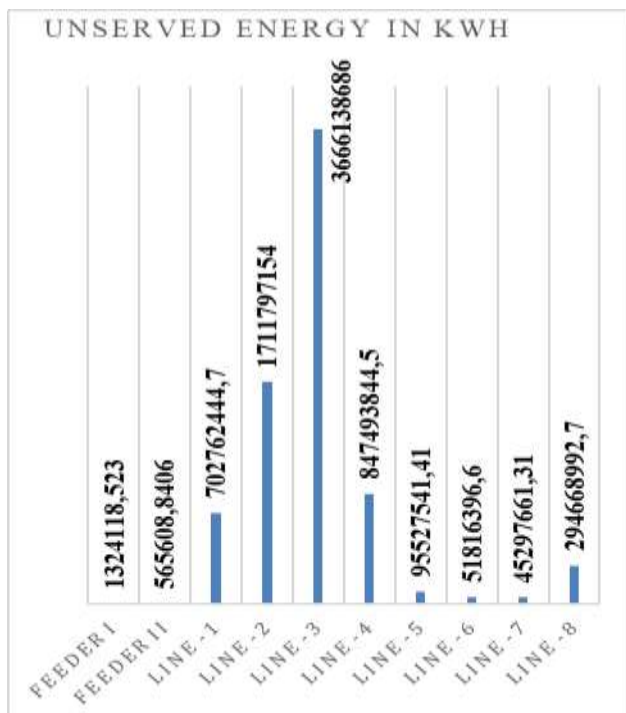
Fig. 5: Kombolcha substation I un-sold energy in KWH within 21 months

Because of continuous interruption occurred on the substation 7,417,392,448 KWH energy lost starting from July-2021 to March-2023 G.C. As shown in Figure 5, huge amount of energy was un-sold, because of the more interruption occurred on line three.

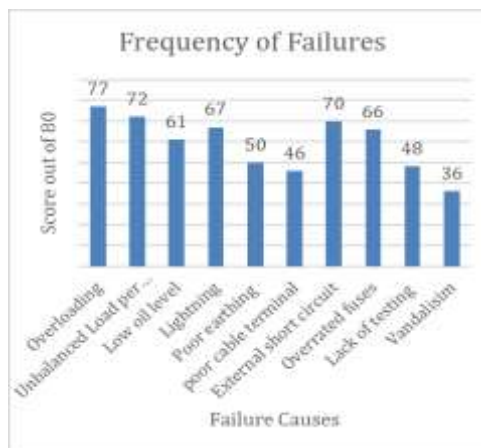
Fig. 8: Frequency of failure causes

From the graph in Figure 8, the major causes of transformer failure include overloading, unbalanced load, low oil level, lightning, short circuits, poor earthing, poor cable termination, over rated fuses, lack of testing, and vandalism were highlighted as a cause of failure. From the graph it was observed that overloading is the most frequently occurring cause with score 77 out of 80. Next to it, uneven loading, short circuit, lightning, over rated fuse, and oil level follow scoring 72, 70, 67, 66, and 61 out of 80 respectively. While vandalism had least effect on the transformer failure with least score of 36. For the question why these problems occurred on the transformers or what were the root causes for the problems, the answers were summarized in Table 3 in descending order of their occurrence as per the questionnaire responses.

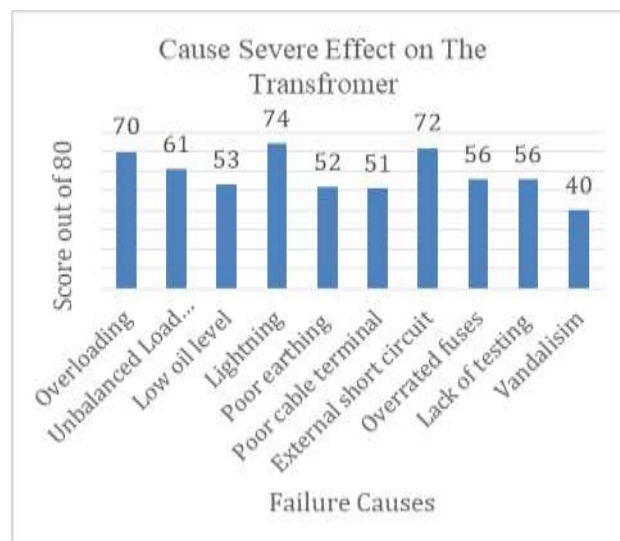
Fig. 9: Plot of the causes that severe effect on DTs

From Figure 9, Lightning with score 74 out of 80 had the most severe effect once it occurred. Next to lightning, external short circuit, overloading, and unbalanced load followed with score 72, 70, and 61 respectively. While vandalism had least severity on DTs. According to the data plotted in the Figure 9, serious care must be taken while giving protection against lightning, external short circuit, overloading and unbalanced power per phases.
