Perceived and Actual Fire Safety – Case of Hybrid and Electric Vehicle Fires in Finland 2015–2023

VESA LINJA-AHO
Independent Electrical Safety Professional,
Espoo,
FINLAND

Abstract: - As an emerging technology, hybrid and electric vehicles draw media attention and so does their fire safety. For this article, Finnish national rescue task database (Pronto) was reviewed for electric and hybrid vehicle fires for years 2015–2023, and the 44 records found were analyzed for the fire behavior and the successfulness of the rescue operation. Hybrid and electric vehicle fires are both absolutely and relatively rare compared to conventional vehicle fires. The incident rate for plug-in vehicles has been 0.2–0.9 per 10000 vehicles per year in the 2020s, which is significantly smaller than the rate for all passenger vehicles (4.6). Small absolute number is due to the small total number of hybrid and electric vehicles. Small relative number of fires may be due to the age of vehicles. Electrified vehicles can catch fire while plugged in, parked or while driving, with no significant differences in the incidence of the state of the vehicle. In road accidents, only one vehicle caught fire after a cr

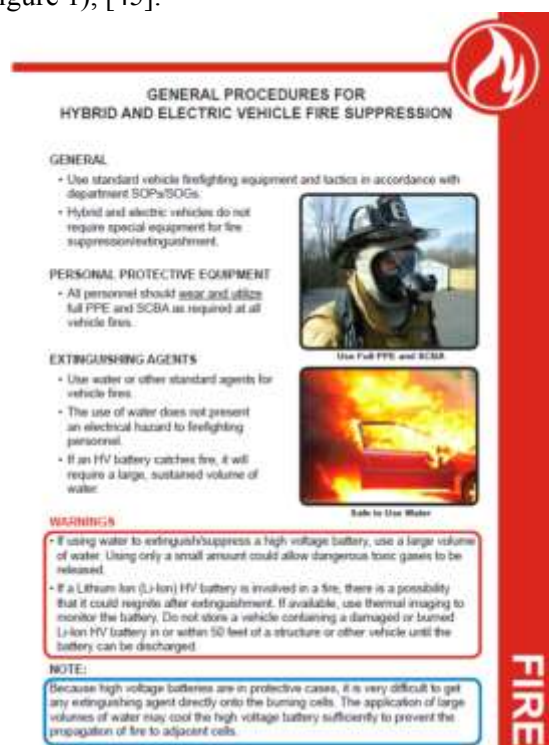
Fig. 1: SAE instructions for first and second responders, [45]

The scholarly knowledge base on electric vehicle fires is at times well-developed and continuously improving further. However, the knowledge and practices should be communicated to the field more efficiently. The rescue and fire staff need clear and brief instructions. A good example of simple instructions is from the United States, in SAE standard J2990:2019 *Hybrid and EV First and Second Responder Recommended Practice* (Figure 1), [45].
